Evaluation of Bridge Deck Overlays

by Rachel J. Detwiler, Tony Kojundic, and Per Fidjestøl

The IL 4 bridge over Interstate 55 was originally built in 1973 on State Route 4 near Staunton, Ill., about 50 mi (80 km) northeast of St. Louis, Mo. It is approximately 300 ft (91 m) long with two traffic lanes separated by a median strip.

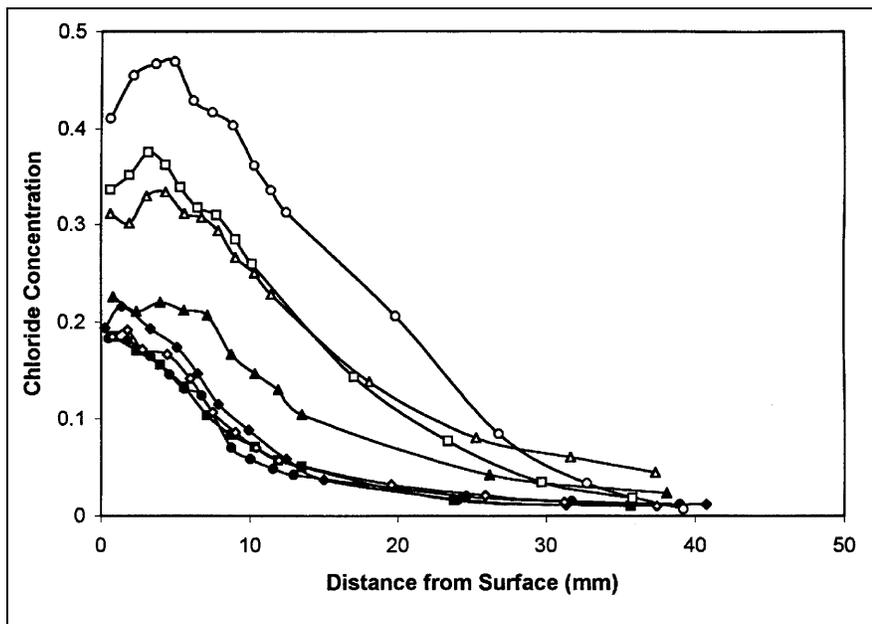
mately 1 mm (0.04 in) thickness. The dust from each layer was carefully collected and analyzed for acid-soluble chlorides. Fig. 1 shows chloride profiles for the silica fume and dense concrete mixes. The lower chloride concentrations near the surface most likely reflect the washing out of the salt with rain. Note that the chloride ion concentration never reaches zero because the local aggregates contain chlorides; it does not reflect the migration of salt from the surface.

Fig. 1 — Acid soluble chloride content, percentage by mass of concrete, vs. distance from surface. The hollow symbols represent the dense concrete (without silica fume) and the filled symbols represent the silica fume concrete. Because the aggregates used contain chlorides, the concentration does not reach zero even at some distance from the surface; this does not reflect chloride ion migration from the surface.
